Green technology as a strategy in managing the black spots in Siak Highway, Indonesia

A Sandhyavitri¹, J Wira¹ and A Martin²

¹Civil Engineering Department, University of Riau, Kampus Bina Widya, Pekanbaru, Indonesia

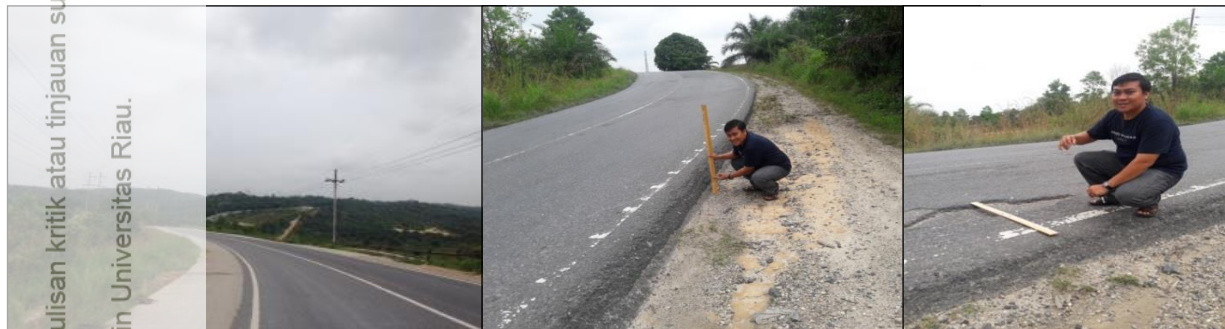
Figure 3. (a) Sharp turnings (bends) without traffic signs and no streetlights, (b) the existing highway condition with no road shoulder and no streetlights, (c) the existing patching holes. Source: Survey data, 2015.

Figure 3a, 3b and 3c shown the existing road turning and pavement conditions were need to repair. In order to repair the patch holes within the locations, the routine road maintenance programs can be conducted as regular bases.

The Figure 3 identified that there is no traffic signs and street lights on that locations. In the evening time, the locations were very dark and prone to traffic accident to occur.

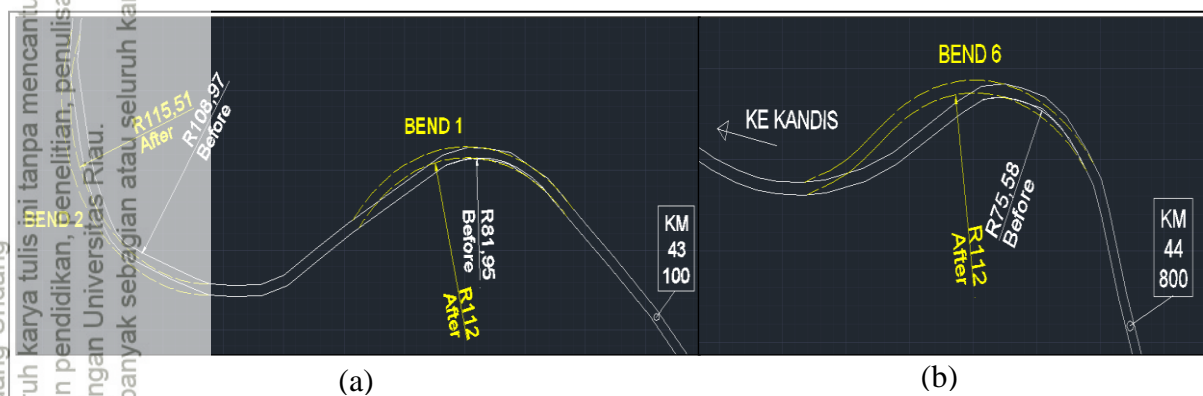
Table 3 and Figure 6 showed that three sharp bends which were a maximum speed less than 60 km/h, this is because of the radius of each bend radius is smaller than the minimum radius standards of 112 meters. The horizontal geometry of this highway segment less than 112 m, thus did not comply the highway bend specification standards [12, 16, 17, 18,19]. Then, it is need to improve the existing horizontal radius alignment of these three turnings (Figure 7a and 7b).

Figure 7. (a) A sharp turning of band 1 within the highway locations, (b) A sharp turning of band 6 (44 + 950) within the highway locations.

For example, it was calculated that the existing Bend 1 horizontal radius was 81.95 m, Bend 2 was 108.97 m, and Bend 6 was 75.58 m. These three turnings need to be extended by the following dimensions 30.05 m, 3.03 m, and 36.42 m respectively to fulfil the radius turning minimum standards of 142 m.

An environmentally friendly approach for mitigating this turning issues can be applied by an improvement of the existing horizontal radius alignment may reduce centrifugal force so that the risk of skidding and sliding vehicles may be declined and as a consequence the number of accidents will be reduced [11].

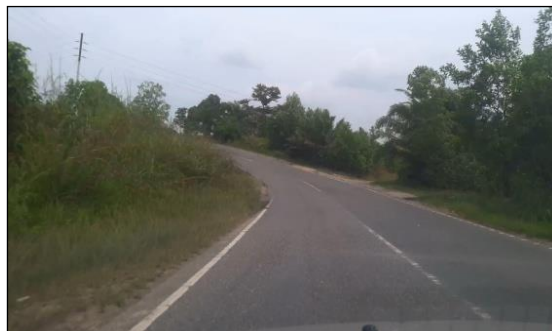
Figure 8. The vertical bends within the existing highway locations at KM 44 + 95.

The existing of black spot condition at the STA 44 + 050 showed that this segment did not have road shoulder, poor street lighting, inadequate traffic signs, no guardrails, and road delineators. The vertical curve was considered high (>30%) (Figures 8 and 9). Hence, these conditions were urgently required to be managed systematically.

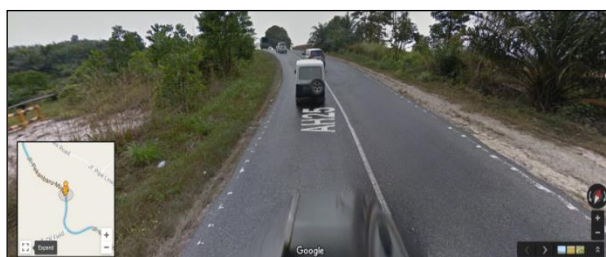
This STA 44 + 050 was described as hilly road conditions, low visibilities, minimum traffic signs and markings, sharp bends, no road shoulders, no lightings, minimum guardrail, hence this STA was considered vulnerable to cause the higher road accidents at this highway segment (Figures 3 and 6).

Figure 9. The situation at STA 44+050 (Before rehabilitation).

This paper highlighted the technical aspects of managing the black spot located in the STA 44 + 050. This may include the constructing of road shoulder to accommodate vehicles to pull over. There is a need to install traffic signs boards such as 'Reduce Speed' sign boards (blinking), road safety (install guardrails), road markings and street lighting, and installing policeman statues equipped with flashing light in order to warn the traffic users to be aware of their safety as showed in Figure 10 [19, 20,

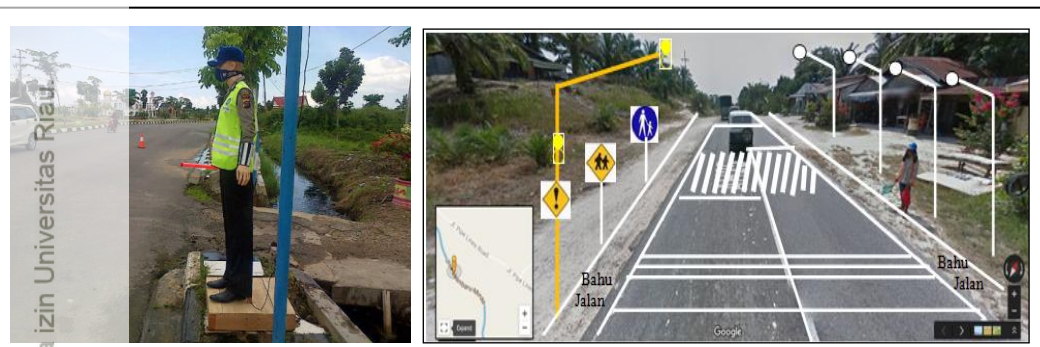
Figure 10. A long climb segment (After rehabilitation).

In this study the overall traffic signs, street lighting and policeman statues equipped with flash light will be proposed based on the green energy technology (Figure 10). Based on M. Richards, D. Carter, 2009 data the public lighting systems are considered as a major source of electricity consumption [23]. Approximately 3.19% of global electricity generation is used for lighting. This amount is greater than production of all hydro or nuclear plants and equals with the production from natural gas [23]. The depletion of fossil energy coupled with the climate change requires finding alternative energy production. Thus, alternative energies know a fast expansion [24].

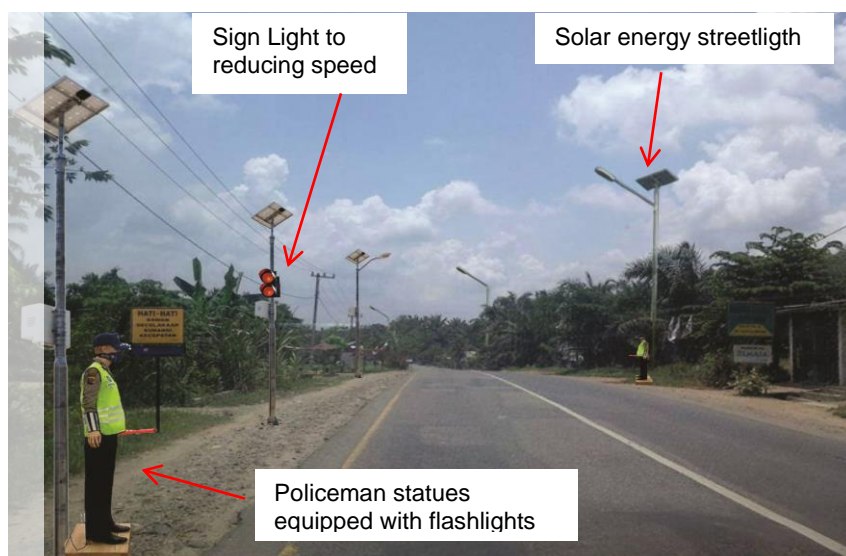
Figure 13. Recommended strategy to reducing traffic accident on the black spots in Siak highway by using green energy technology.

There are 2 main strategies for reducing the number of accidents in the black spot area of KM STA 44

1. Accomplishing the road safety (horizontal alignment improvements) by the extension of the road

equipped with the green road traffic signs, road markings, street lightings and the policeman statues

equipped with flashlights based on solar energy technology as show in Figure 13.
